**PHASE I  
ENVIRONMENTAL SITE ASSESSMENT  
REPORT**

**G.E.G. of Indiana Property  
1010 Keller Drive  
New Salisbury, Harrison County, Indiana**

**September 19, 2011**

**Re: *Phase I Environmental Site Assessment Report  
G.E.G. of Indiana Property  
1010 Keller Drive  
New Salisbury, Harrison County, Indiana  
Linebach Funkhouser Project #196-11***

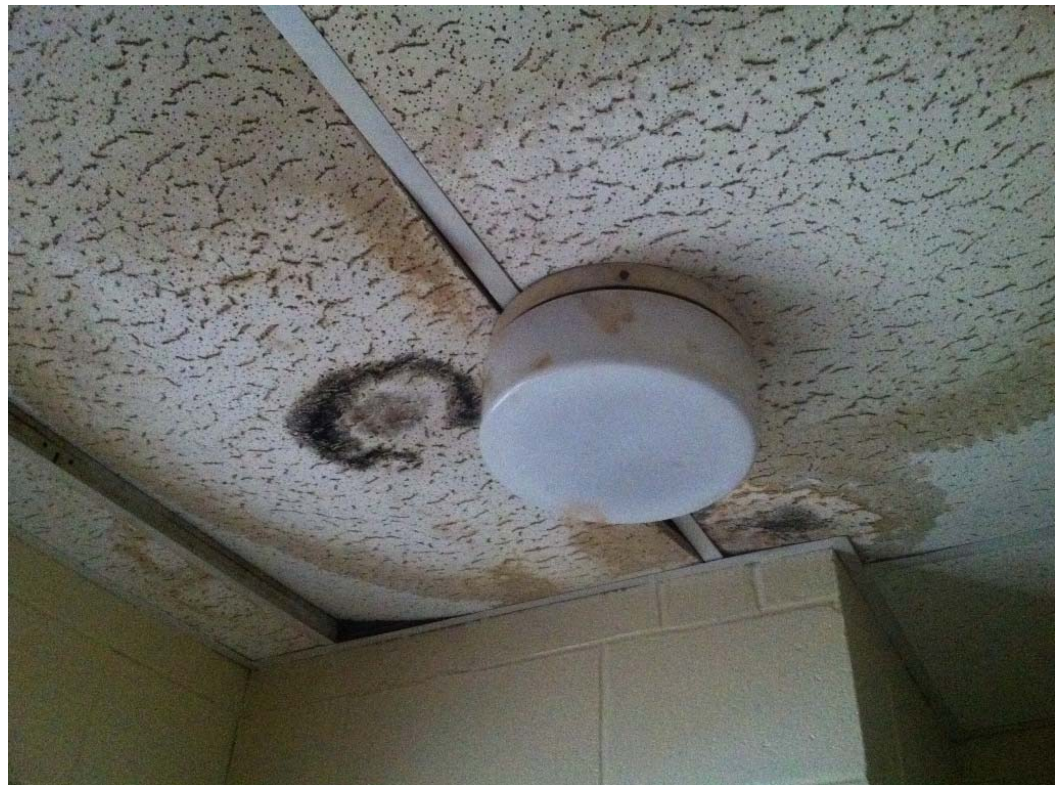
4

Some water infiltration and mold growth was noted on the second floor of the office area.

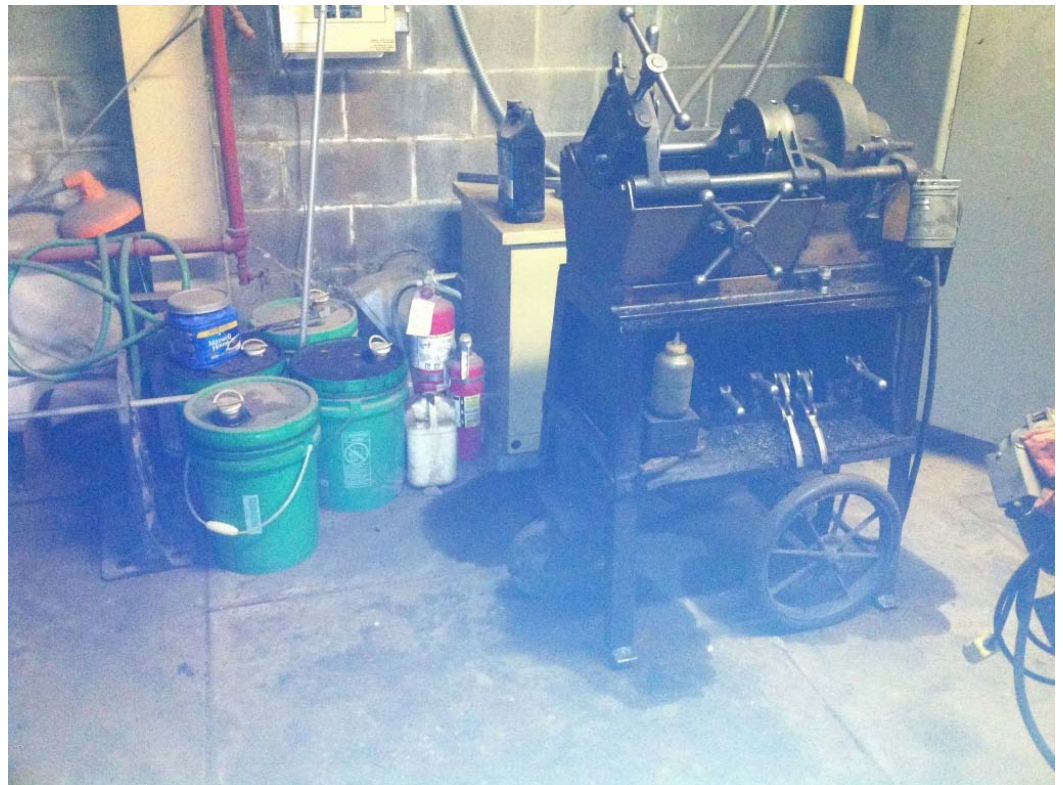
6

A view of some of the chemical products stored in the boiler room of the inactive plant.

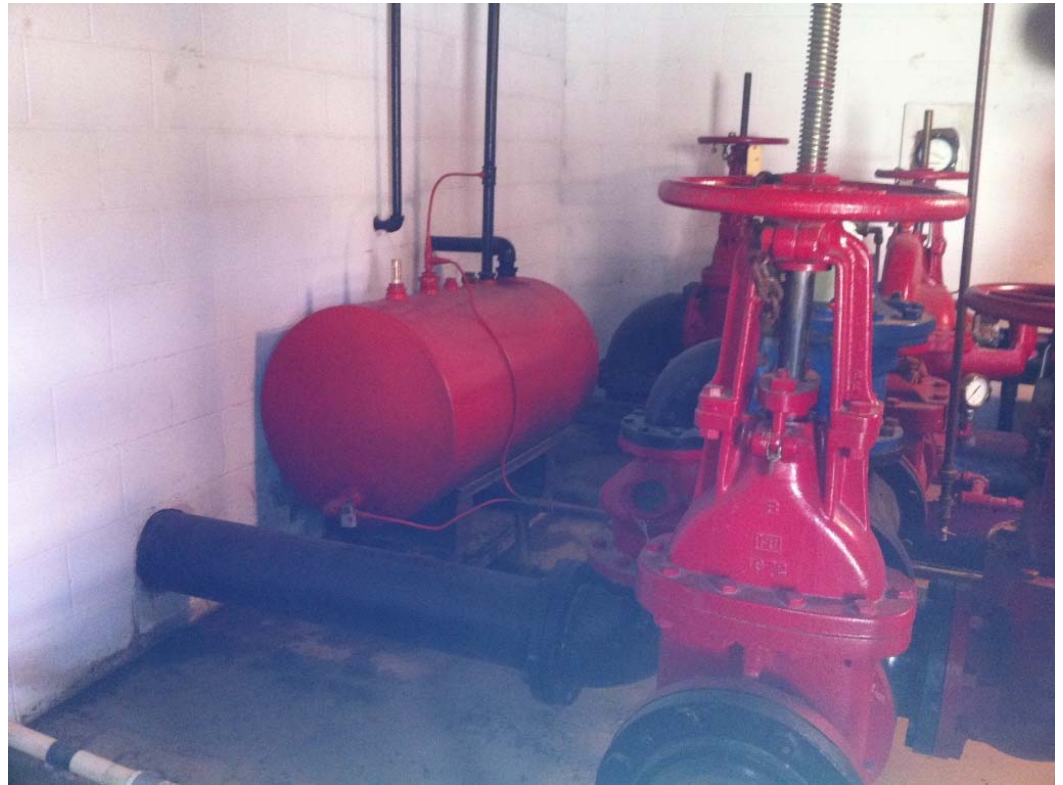
As noted in Section 5.3, one (1) AST was noted in the pump house located southeast of the main building. The approximately 200-gallon capacity tank is used for emergency power backup for the building sprinkler system. No obvious evidence of a release from the AST was observed.

The pump house is connected to a lined reservoir and has an electrical failure emergency backup. The diesel above-ground storage tank ensures that the plant sprinkler system will remain operational at all times.

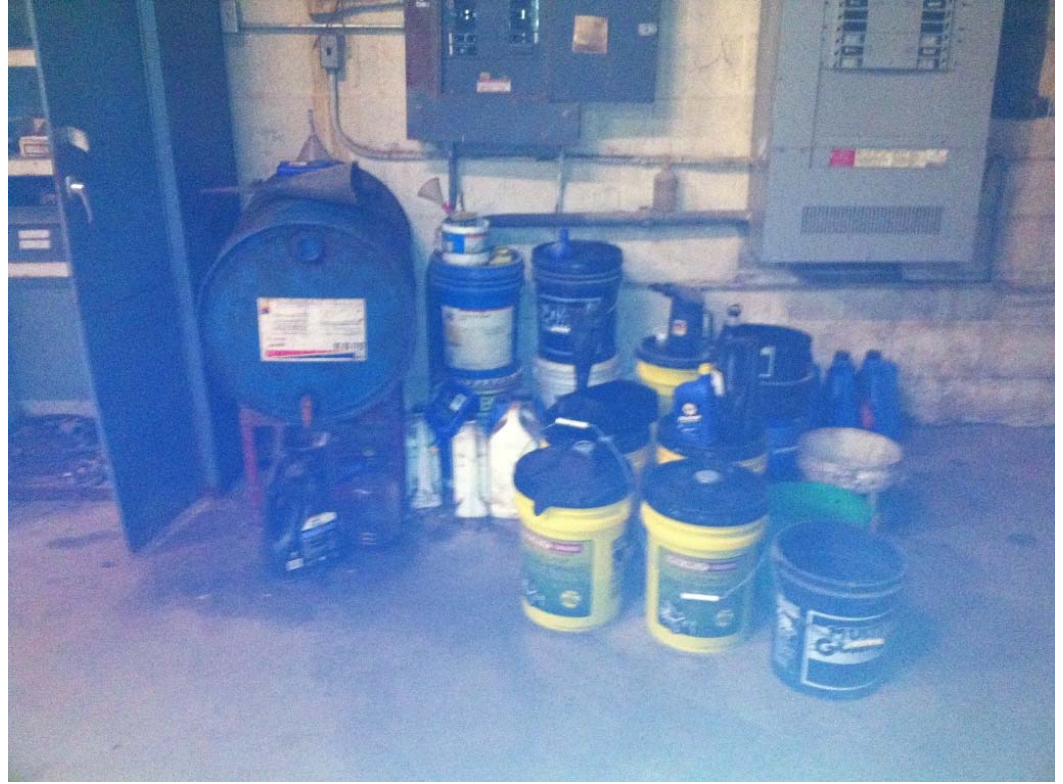
Storage of new and used motor oil in the maintenance area of the plant.

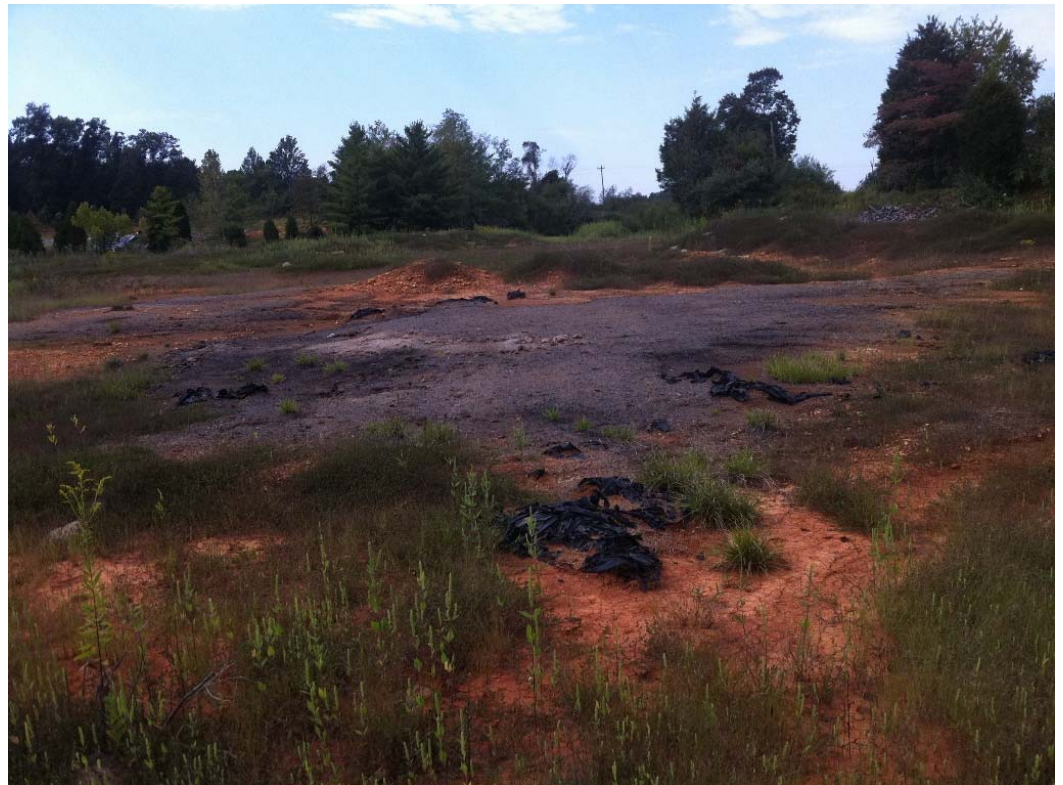
A former sawdust storage area. The sawdust pile was reportedly left by Keller and later addressed by Child Craft.

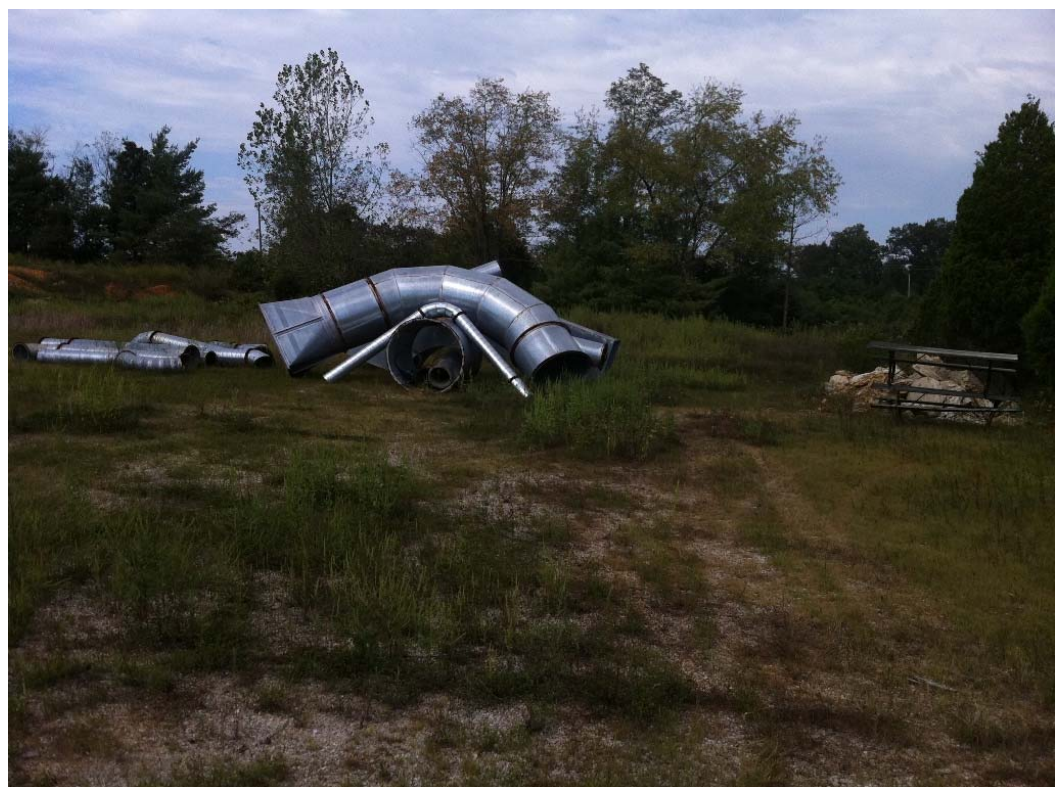
12

The sawdust was reportedly buried in the area behind the scrap metal pile.

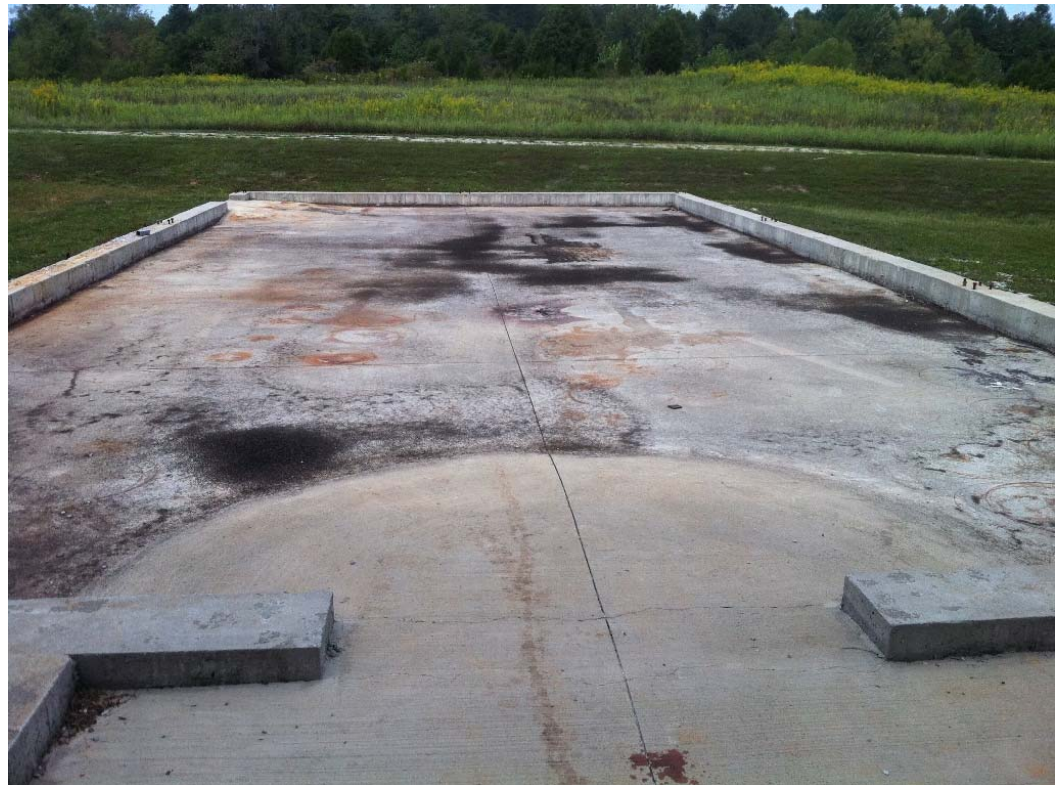
A concrete pad previously used for chemical storage was noted on the exterior of the west side of the building. According to a previous Phase I ESA by LFI, numerous drums of liquid chemical and waste materials were stored there. The pad drained to an outfall location in a ditch that drains parallel to the building to the north. A sample collected from this area during a Limited Phase II investigation in 2008 indicated that the chemical constituents sampled were not detected.

A former chemical storage area was the subject of a 2008 Phase II investigation. No environmental issues were noted with the former storage area.

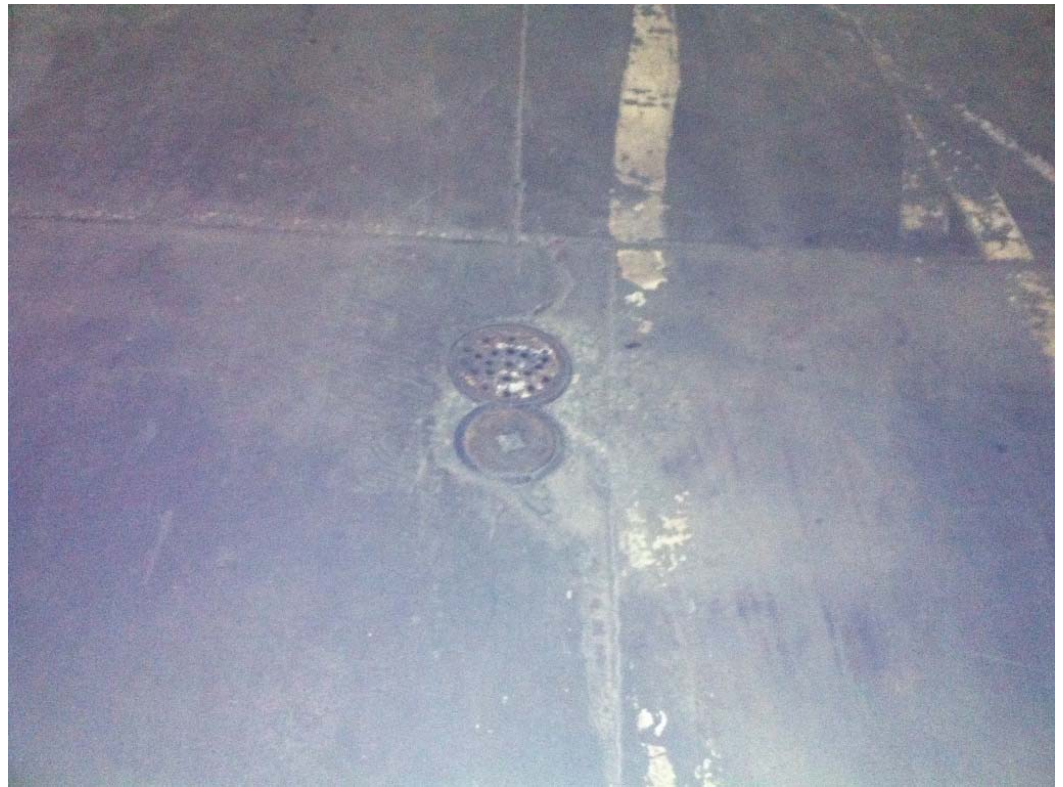
Floor drains were noted throughout the building, both in the office and manufacturing areas. No obvious staining was noted around the floor drains, which reportedly drain to the on-site sewage treatment area.

Floor drains in the facility are reportedly connected to the on-site sewage treatment system. No staining was observed and previous analytical data from the sewage treatment operations did not indicate the potential release of chemical constituents.

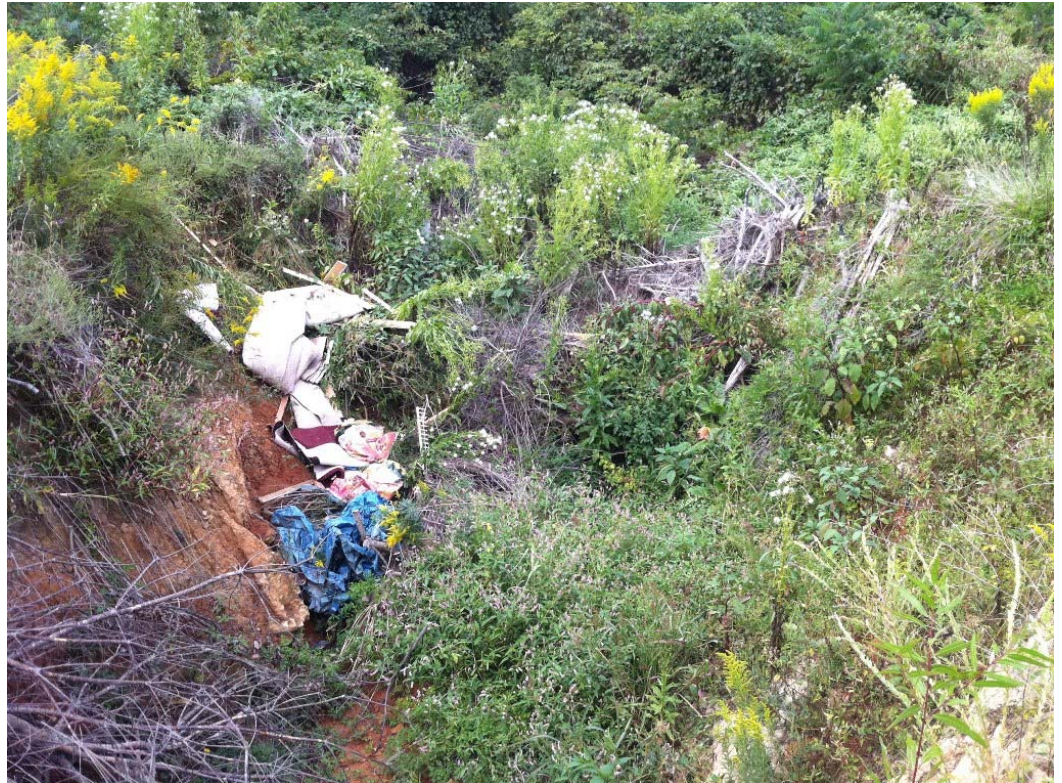
**Comments:**  
Minor waste disposal was noted in a large sinkhole to the west of the former sawdust stockpile.

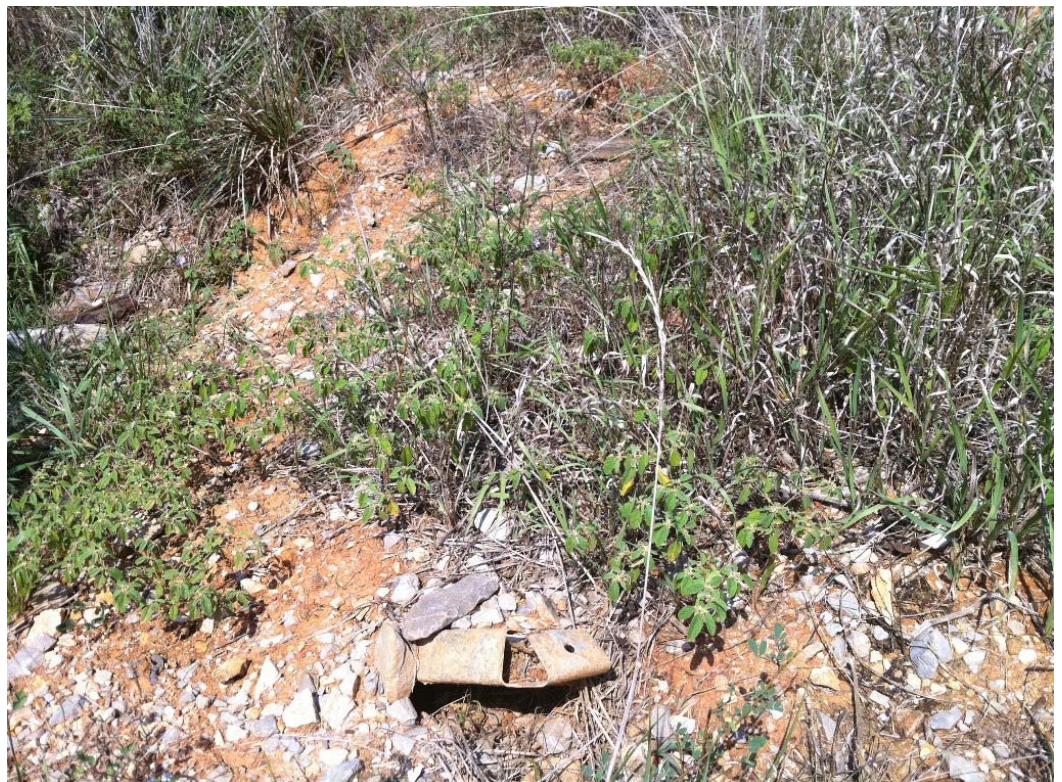
**Photo Number:**  
18

**Comments:**  
A construction debris pile on the west side of the plant (northeast of the sewage area) was reportedly generated from the expansion of the plant in 2005.

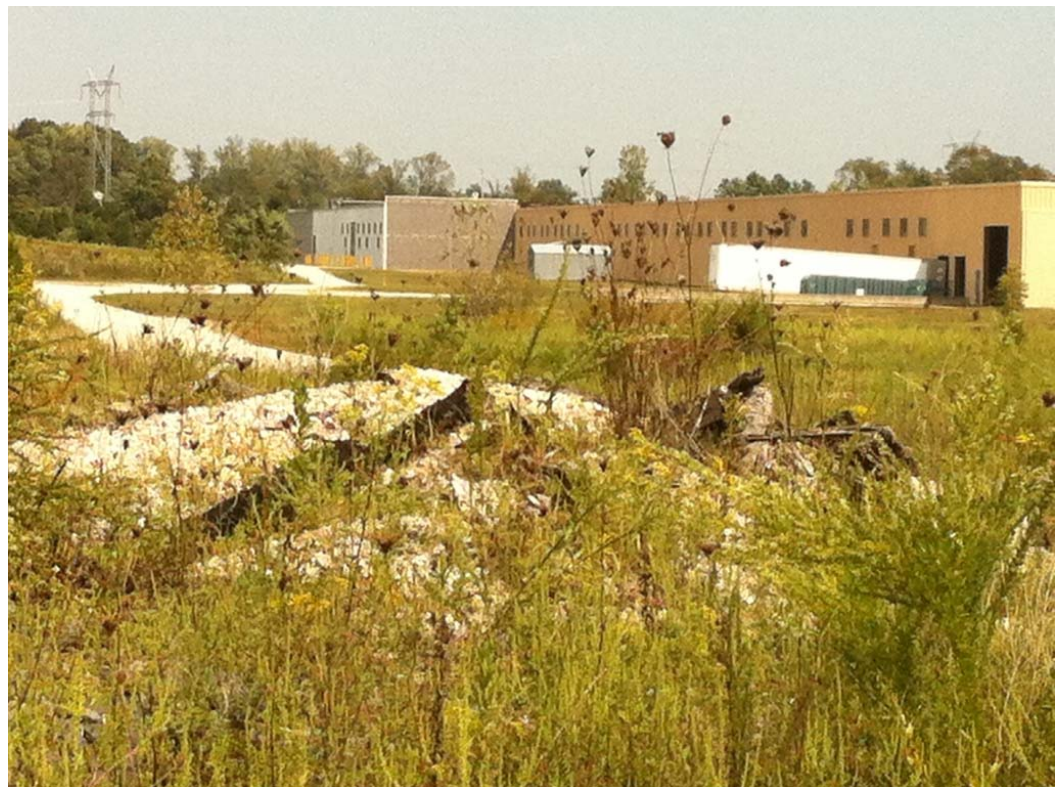
A burn pile area was noted on the southwest portion of the property.

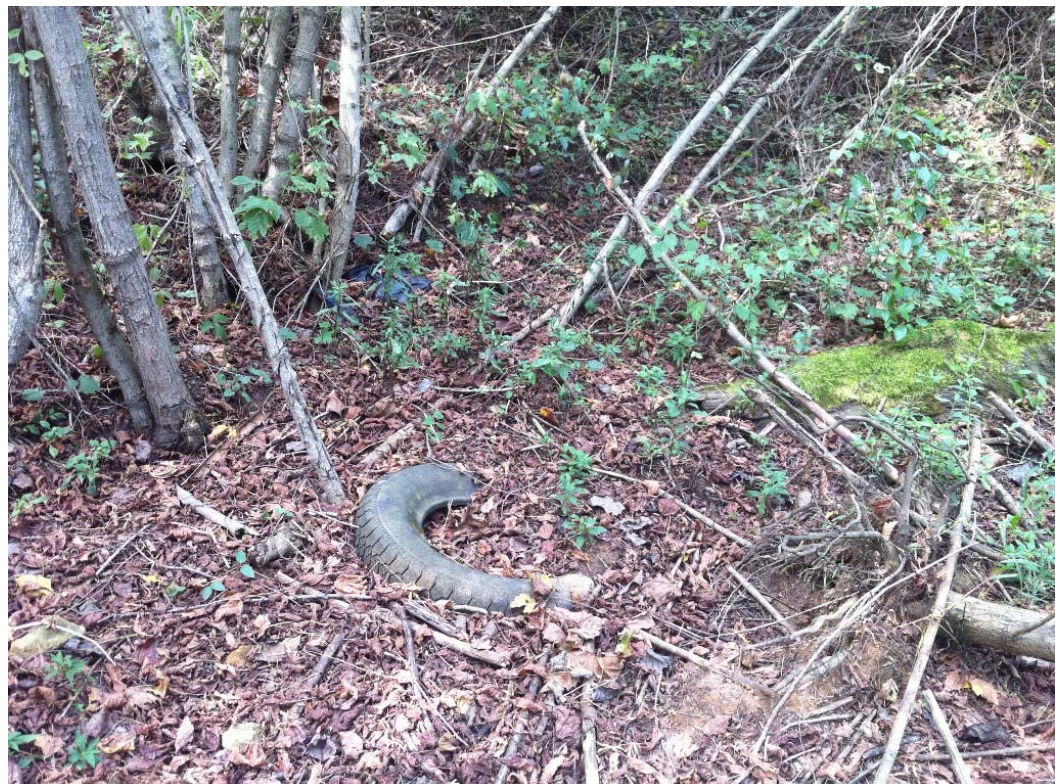
20

Some limited solid waste was noted at various places around the property, including this waste tire in the southeast section of the subject property.
